**-- PASCOAG RESERVOIR UPPER DAM --  
VISUAL  
INSPECTION / EVALUATION REPORT**

Dam Name: *Pascoag Reservoir Upper Dam*

Consultant: *Pare Corporation*

Date of Inspection: *June 8, 2020*

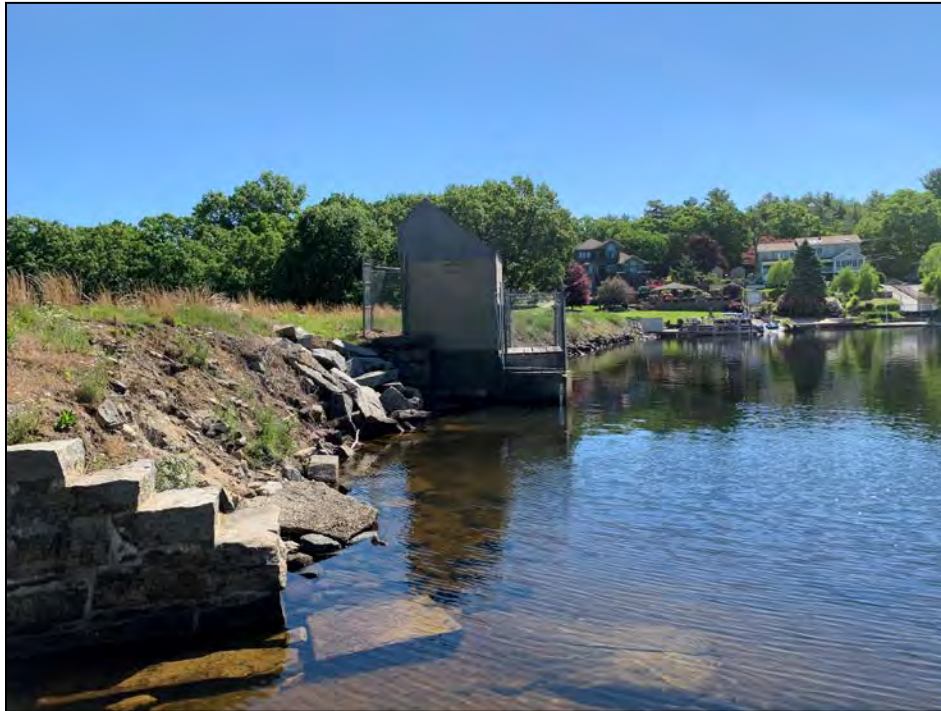
Photo No. 5: Upstream slope between the spillway and low-level outlet. Note bare soil along top of slope.

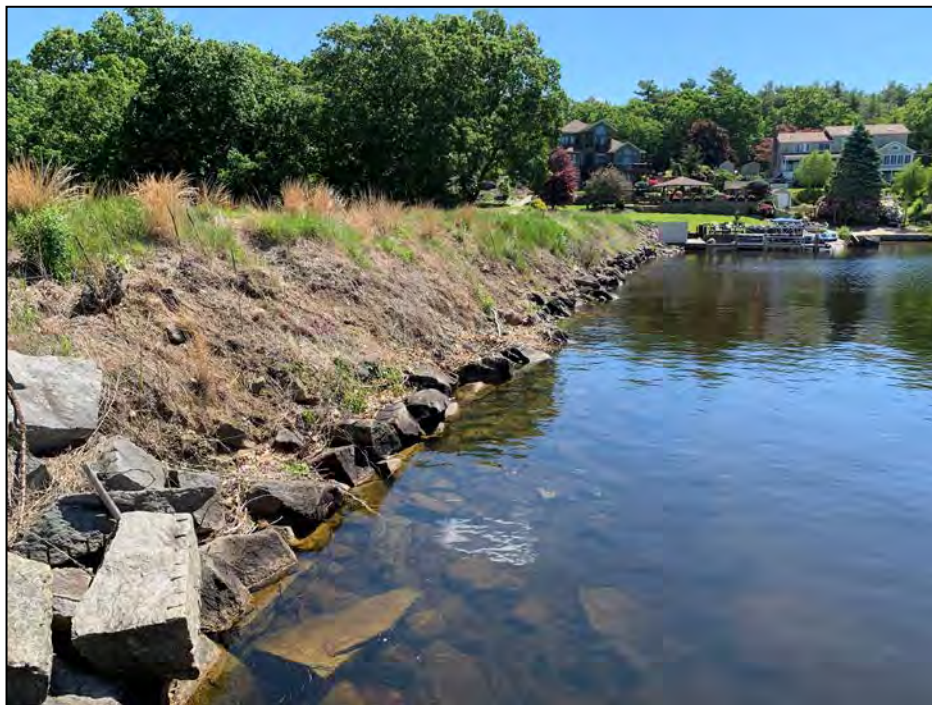
Photo No. 6: Upstream slope right of the low-level outlet. Note bare soil throughout the slope.

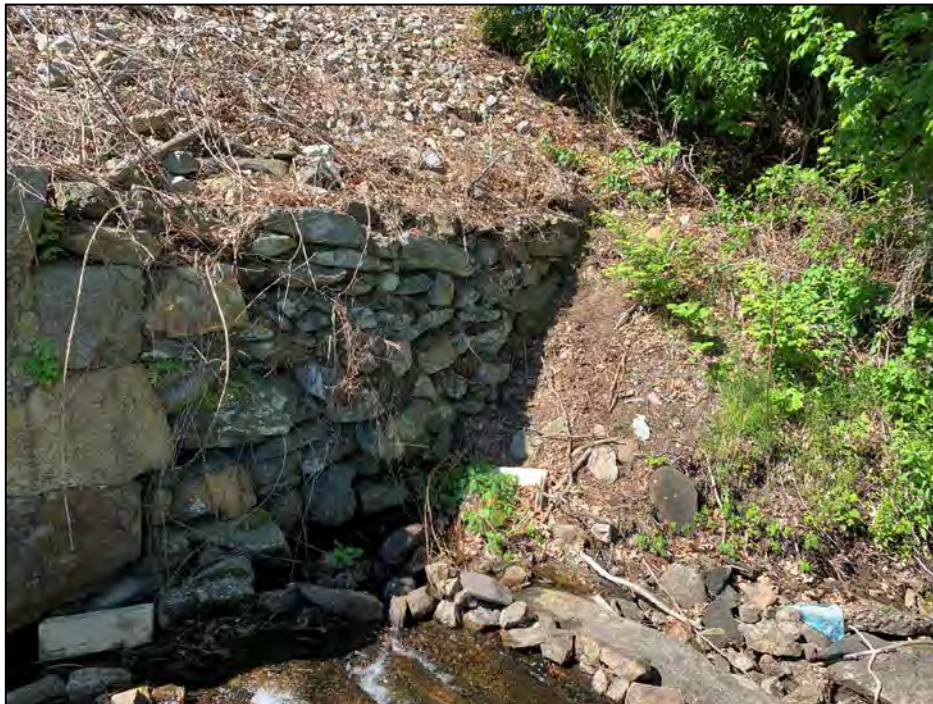
- The downstream wall left of the spillway appeared to be in good condition. No deficiencies were apparent along the downstream stone wall left of the spillway.

Photo No. 12: Downstream wall and downstream slope left of the spillway.

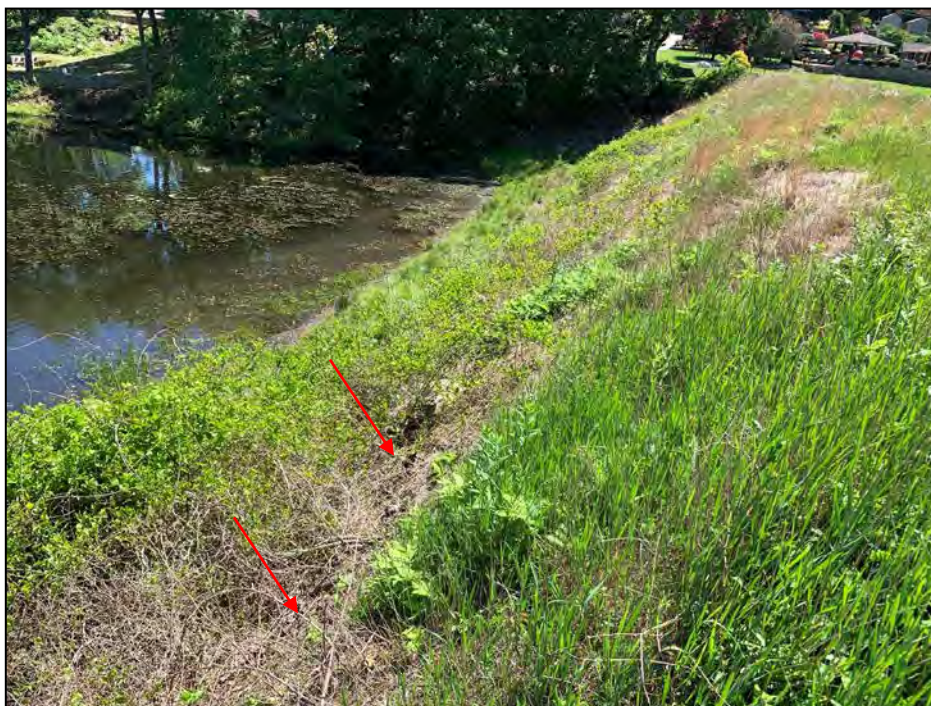
Photo No. 14: Pair of animal burrows (arrows) located 50 feet right of the low-level outlet.

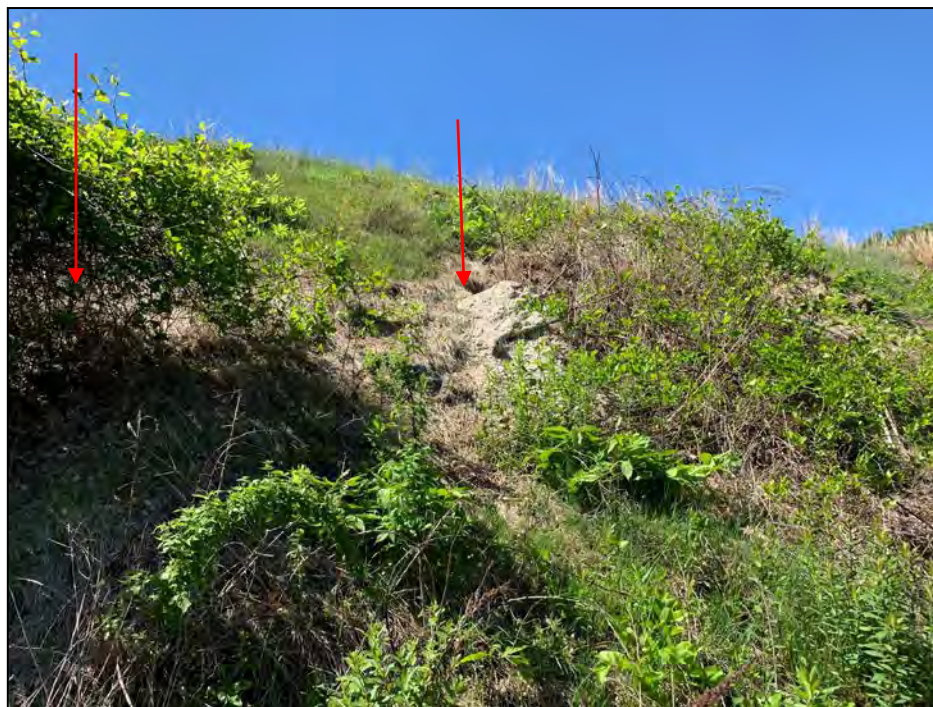
Photo No. 16: Pair of animal burrows (arrows) located approximately 100 feet from the right abutment.

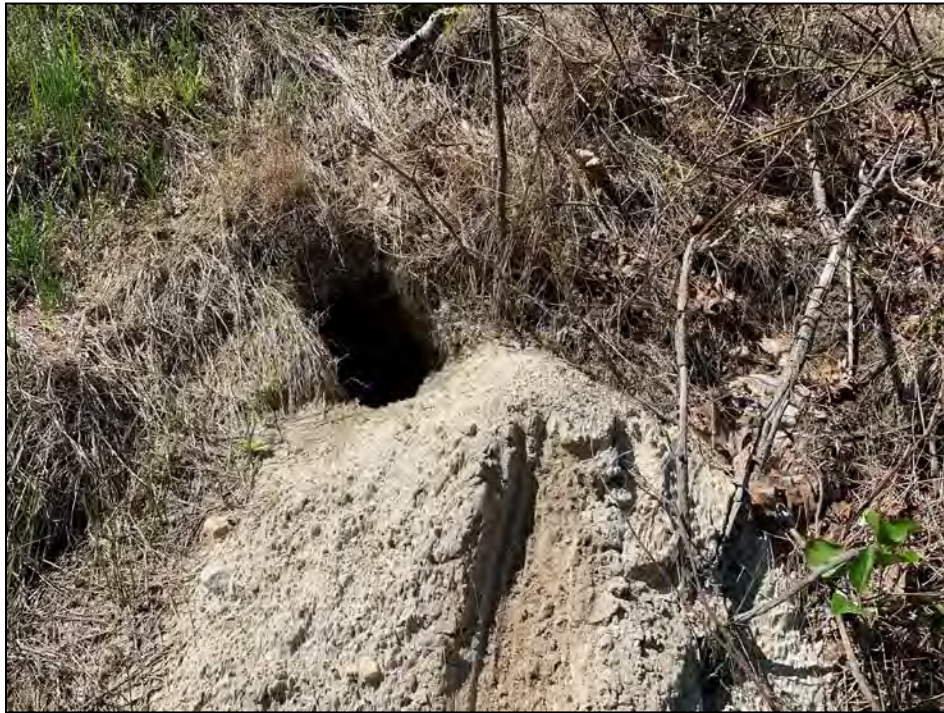
Photo No. 17: View of one of the burrows. Note diameter (12 inches) and soil spoil pile (silty fine sand) typical of all four apparent burrow locations.

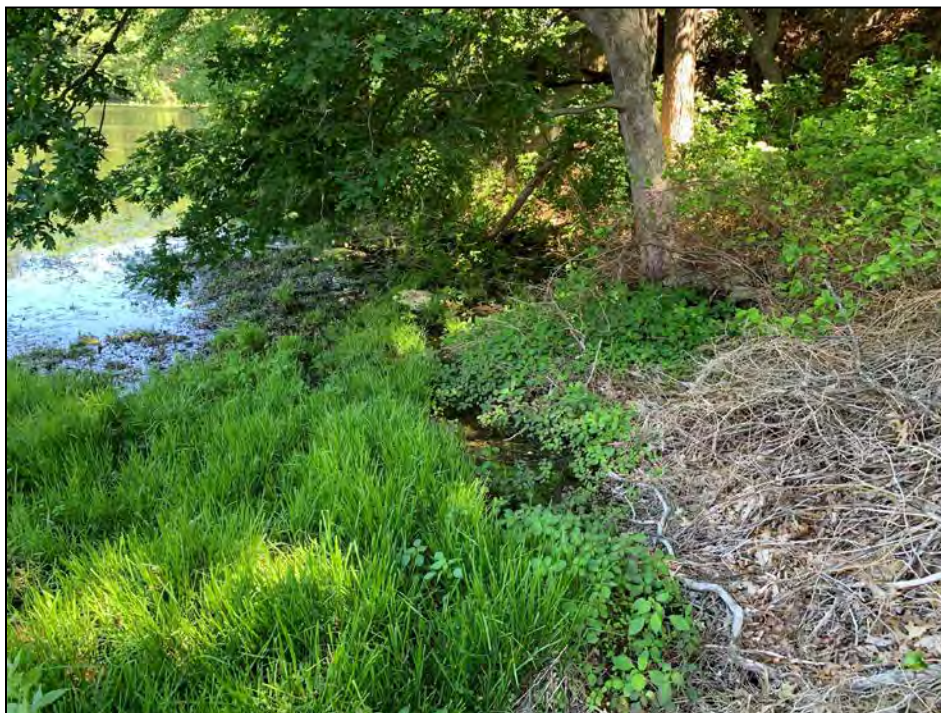
- Signs of apparent seepage was present at the toe of the right groin with lush vegetation and soft saturated soils within 20 feet of the groin.
- Other areas of the toe of the slope were observed to be soft and saturated. It was unclear if this was related to seepage through the dam or the result of capillary action associated with the downstream tailwater.

Photo No. 19: Apparent seepage area at the toe of the right groin of the downstream slope.

12. Evaluate the wet areas along the downstream toe. If related to seepage implement a seepage mitigation system	<i>No apparent change / Same recommendation</i>

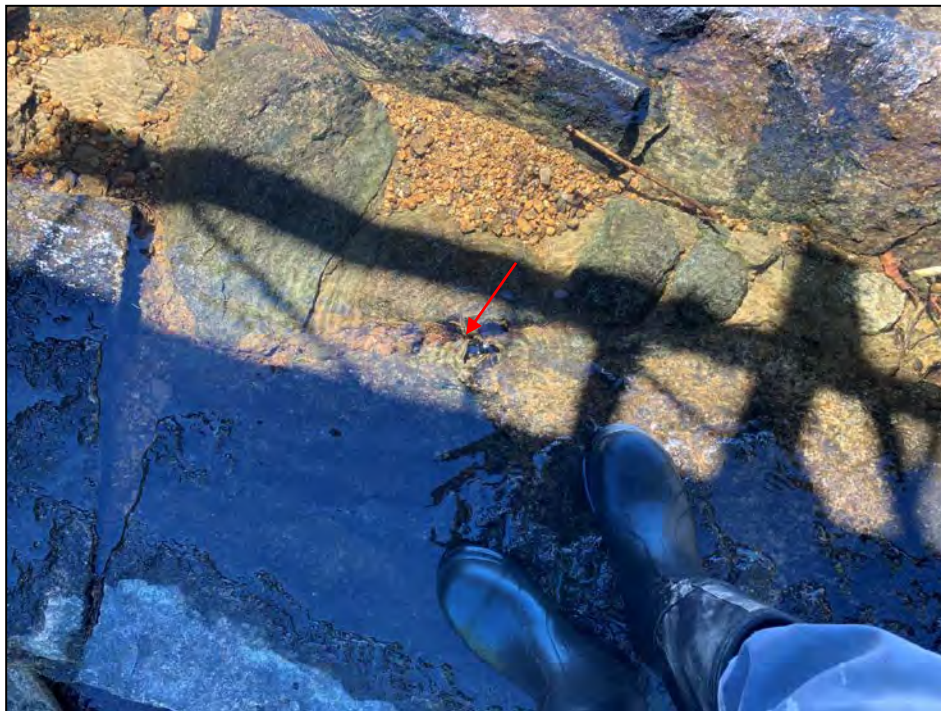
- Leakage was present through the spillway control section (approximated at 200-300 GPM).
  - The apparent source of the leakage appeared to be through several sections of the open masonry along the top of the control section. Several vortexes were observed along this section.

Photo No. 22: Vortexing (arrow) of leakage flow through the open masonry of the control section.

1. Develop and implement a formal monitoring program and evaluation to further assess the observed vortices, large flow of leakage, and observed ponded wet area near the toe of the spillway right training wall and flow through the base of the wall 10-feet from the downstream end of the training wall. The program should include procedures for locating sources of flow and recording observed flow rates and ponded levels, in relation to varying levels of the impoundment, and monitoring the wet areas for indications of sediment transport and volume of transported soil.

- a. Conditions are as suspected with either flow through open joints of masonry and/or stone masonry founded on bedrock. Continued monitoring is still recommended; however a concrete approach slab tied into bedrock or other means of leakage deterrent may be needed to address the ongoing leakage.

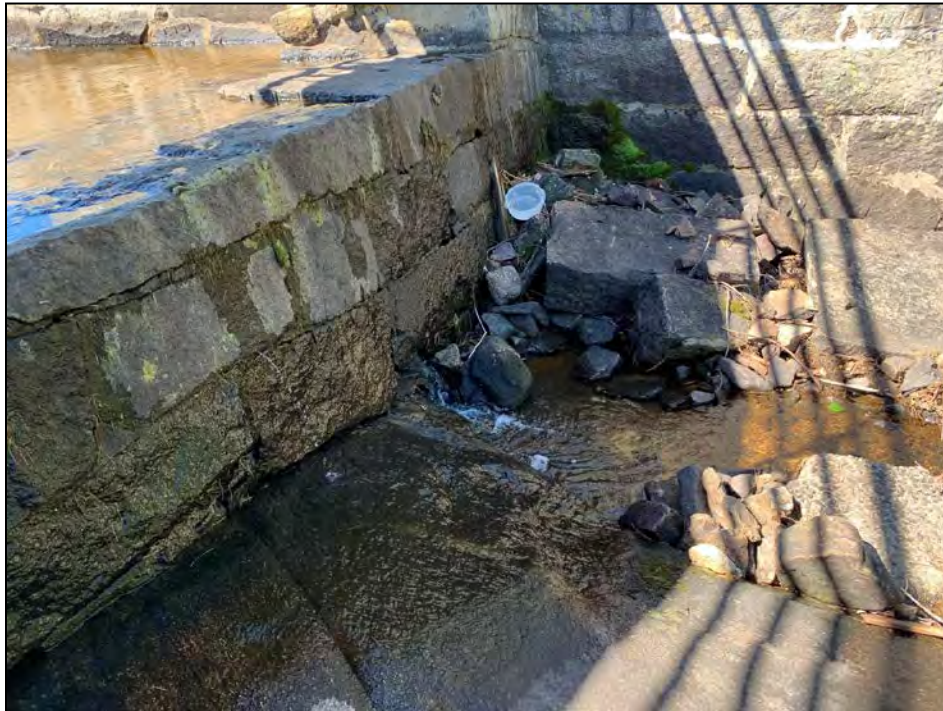
- The majority of the leakage exited from the toe of the control section with some of it flowing out of the second course of stone from the bottom.
  - The caretaker indicated that they would reevaluate the leakage at a lower pool level when the top of this control section is unsubmerged to determine if the sole source of the leakage is the top of the weir. If confirmed to be the sole source; a repointing program will be implemented in an attempt to stop the leakage.

Photo No. 23: Leakage through the spillway control section.

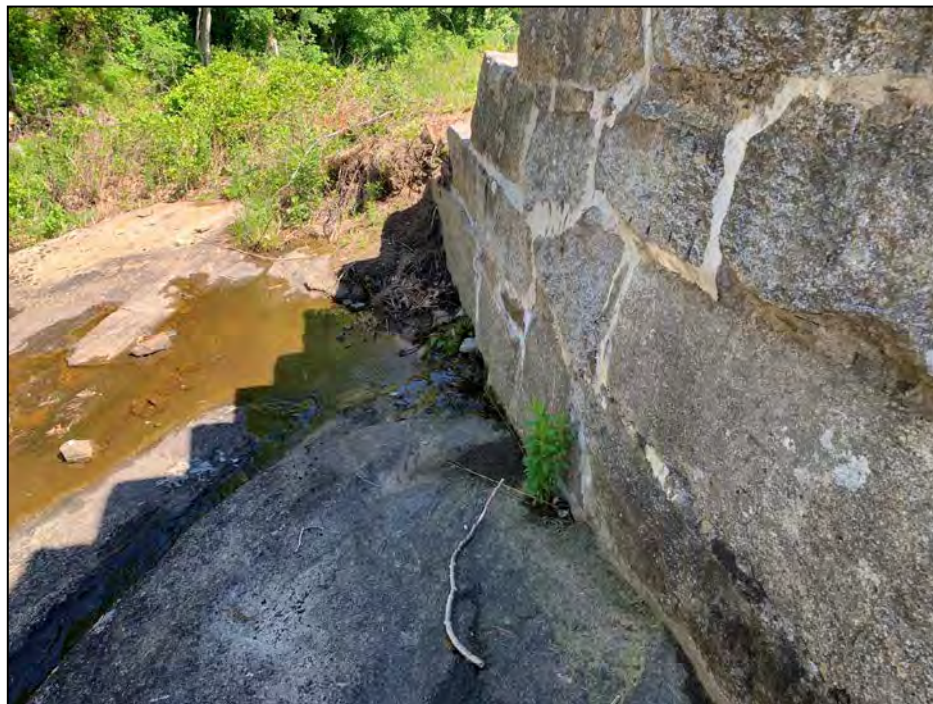
- Leakage was also present (approximated at 2 GPM) from the base of the right training wall located approximately 10 feet downstream of the control section.

Photo No. 24: Leakage through the base of the downstream right training wall approximately 20 feet downstream of the control section.

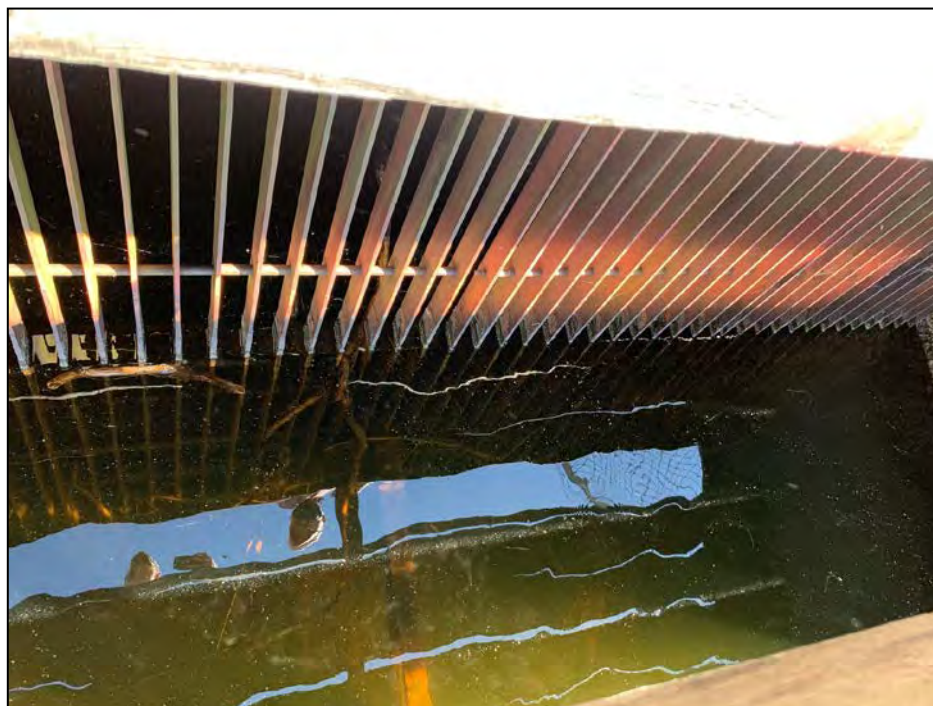
- The trash rack appeared rusted but no section loss was noted.
- There was no apparent debris upstream of the trash rack.
- No apparent deficiencies were noted within the gatehouse interior.
- The caretaker indicated that the gate was in their maximum fully closed position (which is leaving it 2 inches open to maintain minimum baseflows).
- The gate was operated during the inspection without issue.
- No apparent deficiencies were noted along the downstream headwall.
- The outlet end of the outlet conduit was submerged and not visible.

Photo No. 26: Trash racks at the inlet end of the low-level outlet system.

11. Continue gatehouse maintenance including replacing the stop log stanchions at the outlet approach, remove scaling rust from and painting the trash rack.

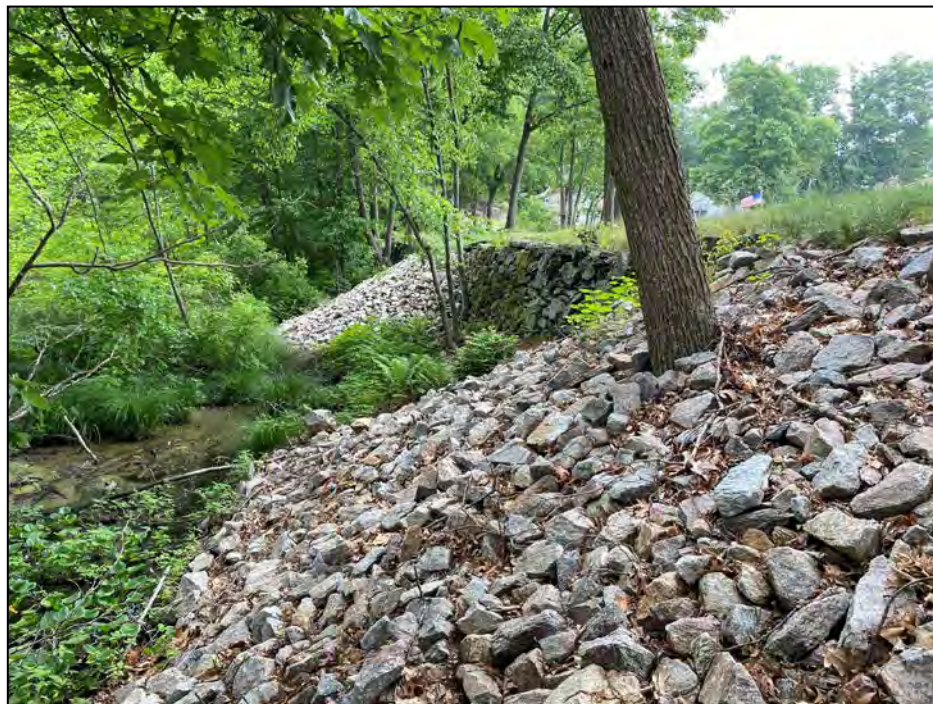
- The downstream wall has numerous areas of apparent movement and questionable stability.
- Two trap rock buttresses have been installed along the steepest sections of the wall (presumably at the two failed sections of the wall that were reported on in the 2017 report)
- A wetland complex was present downstream of this section of the intact portion of downstream wall. It is unknown if seepage through the dike feeds and/or creates this wetland complex.

Photo No. 36: Downstream side of the dike from near the tallest section looking right. Note the two trap rock buttresses and ponded water within the downstream area.

2. Regrade the crest to a level section with compacted fill; reseed to establish grass growth.
3. Complete stability analyses to evaluate the observed bulges and overall condition of the upstream and downstream walls. In order to complete these analyses, the completion of subsurface investigations will likely be required to assess the current conditions of the embankment soils.

4. Based on the results of the stability analyses, repair both the upstream and downstream walls. Reset the displaced stones as necessary to form vertically and horizontally regular walls. This may include providing additional chinking stones, repointing, or installing a stone buttress in front of the walls for added stability.

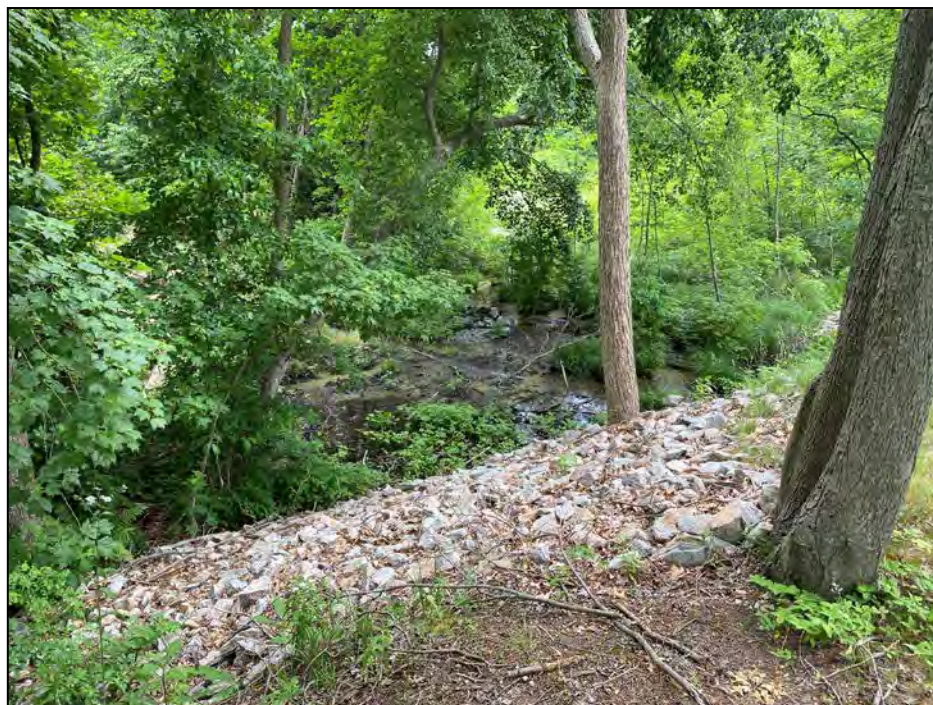
Photo No. 38: View of the area downstream of the dike. Note ponded water and wetland type vegetation.
