# Pascoag Reservoir Upper Dam

## VISUAL INSPECTION / EVALUATION REPORT

Dam Name: Pascoag Reservoir Upper Dam  
State Dam ID#: 016  
Owner: Colleen Conley (Main Dam); Chad Dumouchelle (West Dike)  
Town: Burrillville  
Consultant: Pare Corporation  
Date of Inspection: September 30, 2025

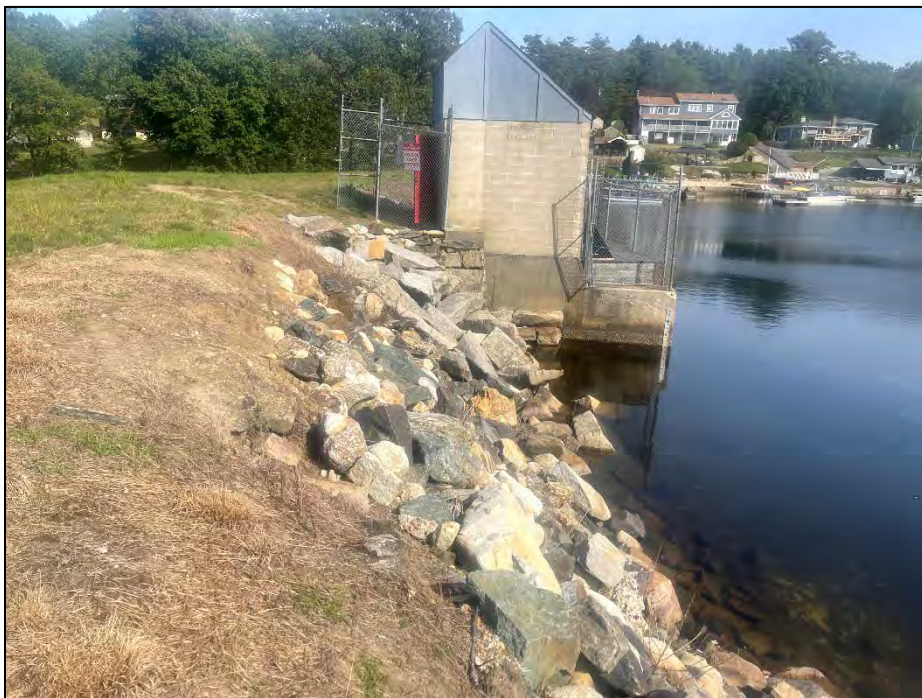
Photo No. 2.: Upstream slope as viewed from left of the primary spillway looking right. Note areas of thinning grass and bare surfaces along the upper part of the slope.

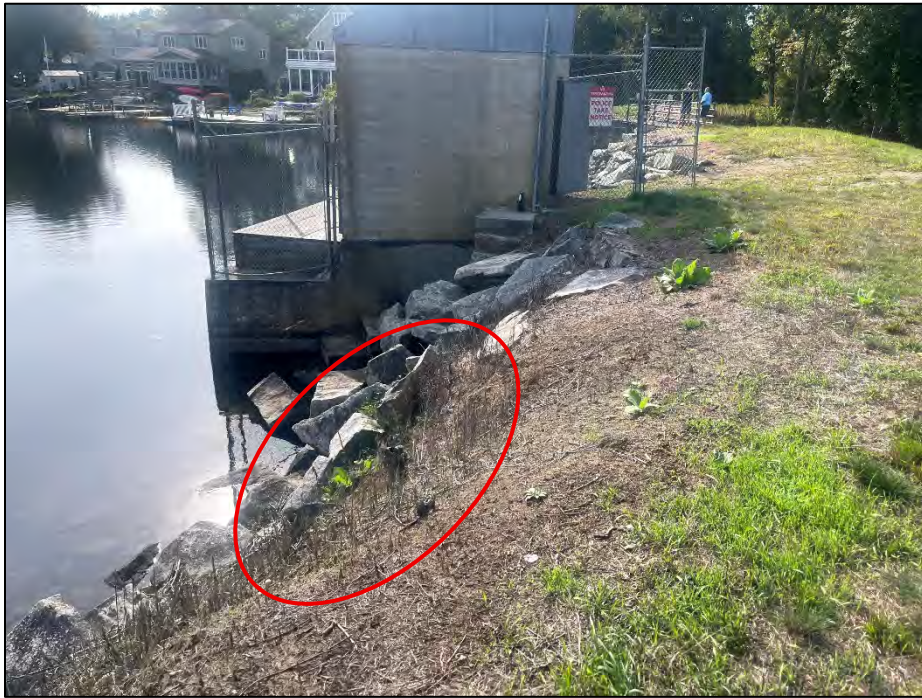
- A surficial slide was observed near Sta. 2+50. The area extended from the top of the slope to above the riprap and was up to 2 feet wide. PRDMD board members present during the inspection stated these types of surficial slides occur often and are readily repaired.
- Starting at about 12 to 18 inches above the waterline, the slope transitions to riprap which extends below the waterline. The riprap is up to about 18 inches in diameter and appears evenly distributed.

Photo No. 3.: Upstream slope as viewed from the crest near STA 2+00 looking left. Note area of shallow sliding failure (circle).

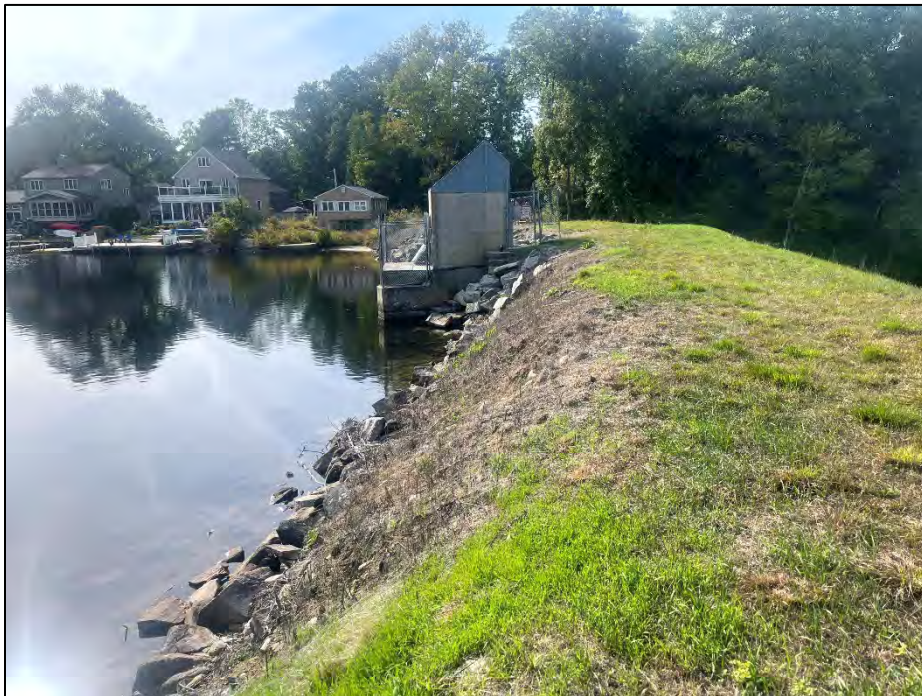
Photo No. 4.: Upstream slope as viewed from the crest near STA 2+60 looking left. Note areas of unraveled grass and shallow sliding failures.

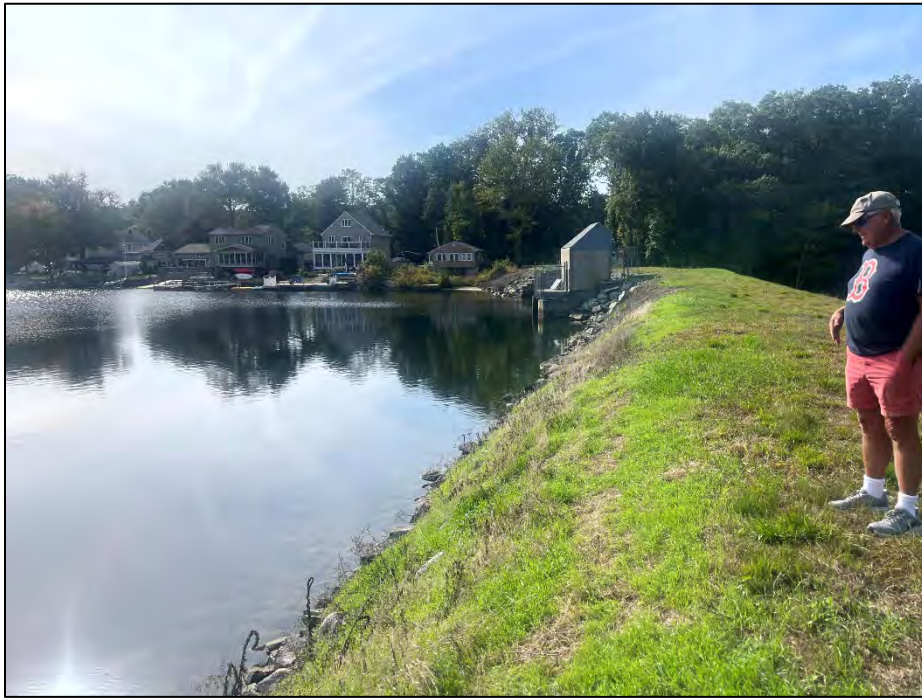
Photo No. 5.: Upstream slope as viewed from the crest near STA 4+10 looking left. Note typical steep slopes and sparse erosion protection.

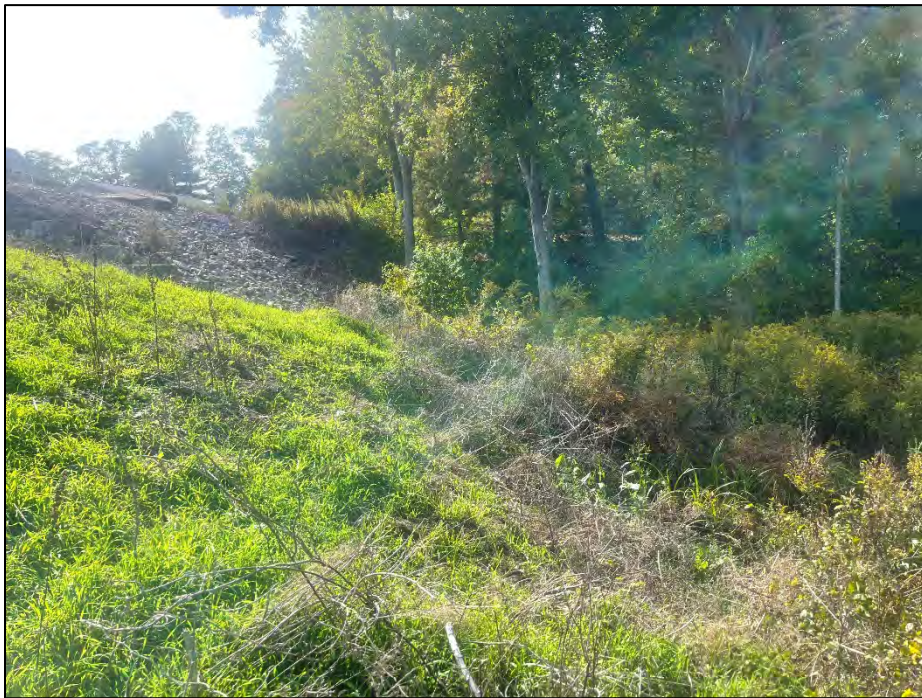
Photo No. 12.: Downstream slope as viewed from near STA 1+00 looking left. No riprap was observed up to the primary spillway; however, no erosion is noted.

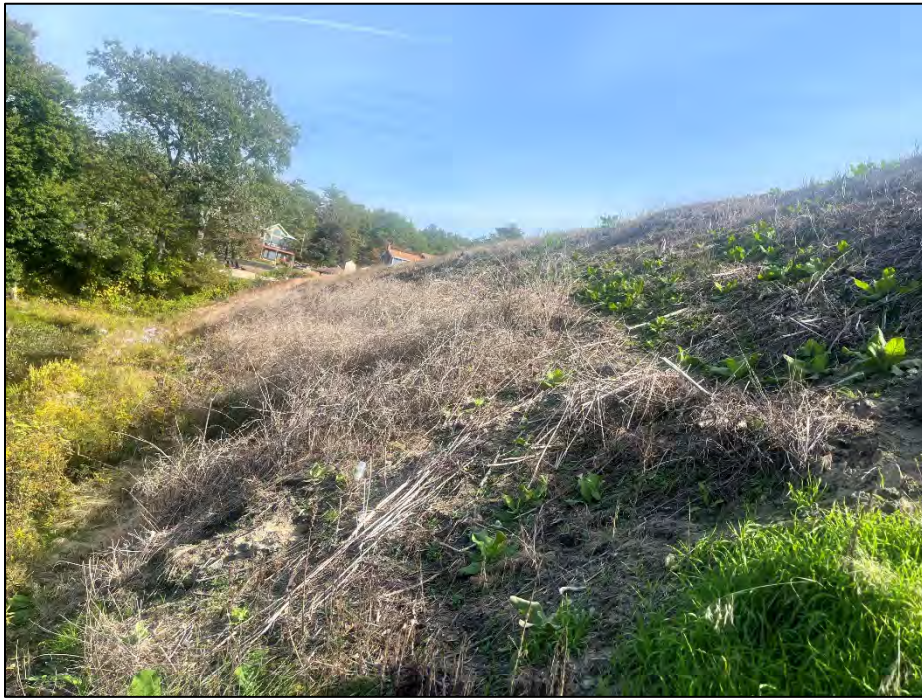
- Soft, wet soils are present along the lower quarter of the slope. While indicative of seepage, no areas of concentrated flow were observed. No staining was observed along the wet surfaces.

Photo No. 13.: Downstream slope as viewed from right of the low level outlet looking right. Note the steep slope, and the damp and soft toe as identified by the greener vegetation.

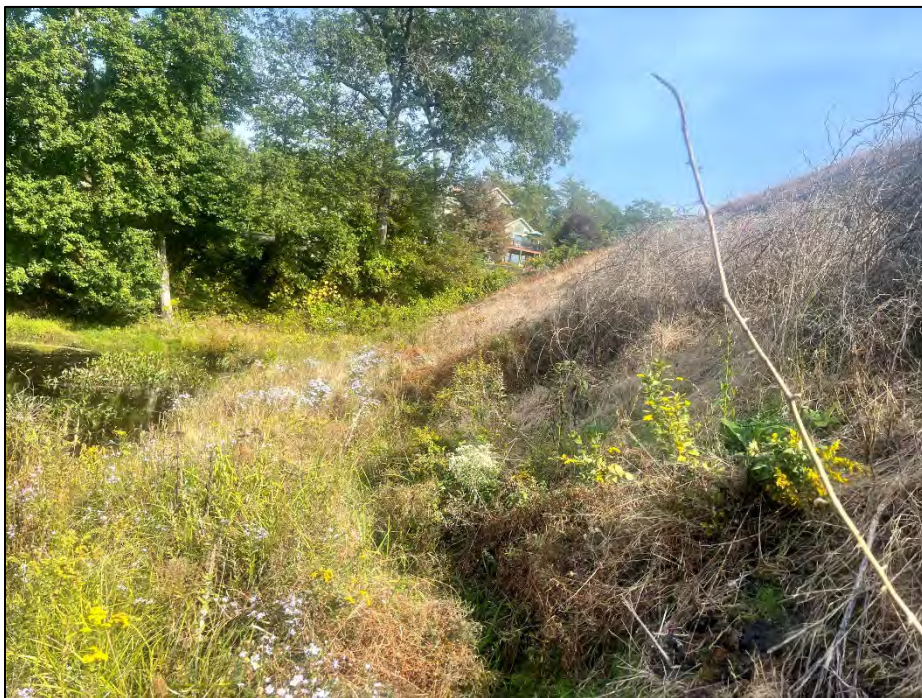
Photo No. 14.: Downstream slope as viewed from near STA 3+00 looking right. Note wet area along toe in the immediate foreground.

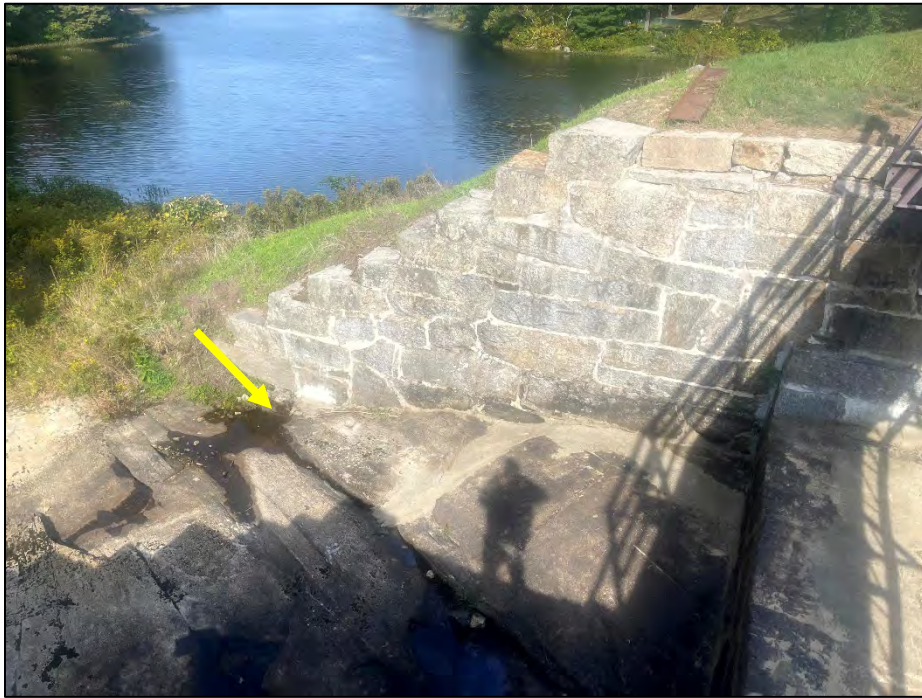
- Previously reported leakage through the spillway control section could not be evaluated because water levels were presently below the base of the control section wall (i.e., no differential head).
- The previously reported leakage from the base of the right training wall located approximately 10 feet downstream of the control section was not detected.
- Distinct areas of clear leakage were observed discharging from joints within the exposed rock outcrop located in the spillway discharge area between the training walls. The seepage flow rate was estimated to be less than 0.5 gallons per minute.

Photo No. 17.: Primary spillway downstream right wall. Note area of historic leakage (arrow).

1. Continue to develop, refine, and implement a formal monitoring program and evaluation to further assess the observed vortices, large flow of leakage, and observed ponded wet area near the toe of the spillway right training wall and flow through the base of the wall 10-feet from the downstream end of the training wall. The program should include procedures for locating sources of flow and recording observed flow rates and ponded levels, in relation to varying levels of the impoundment, and monitoring the wet areas for indications of sediment transport and volume of transported soil.

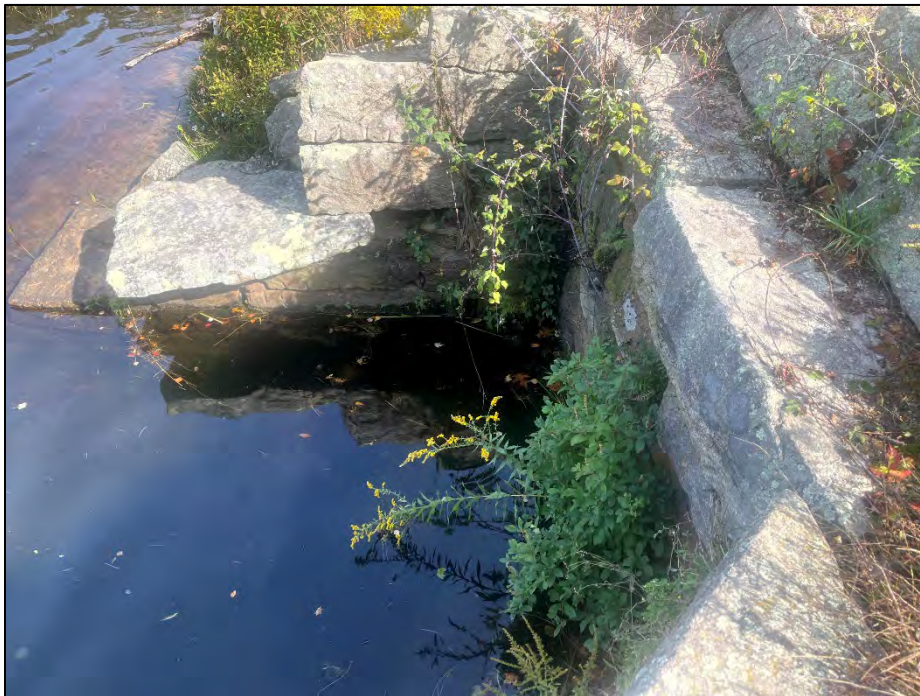
Photo No. 22.: Low level outlet downstream headwall. Note shifted wall stones and open joints, typical throughout the discharge structure.

5. Complete regular mortar maintenance along the spillway structures.
6. The low level outlet downstream headwall was found with shifted stones and minor gaps. Complete maintenance-level repairs including resetting the stones and chinking work.

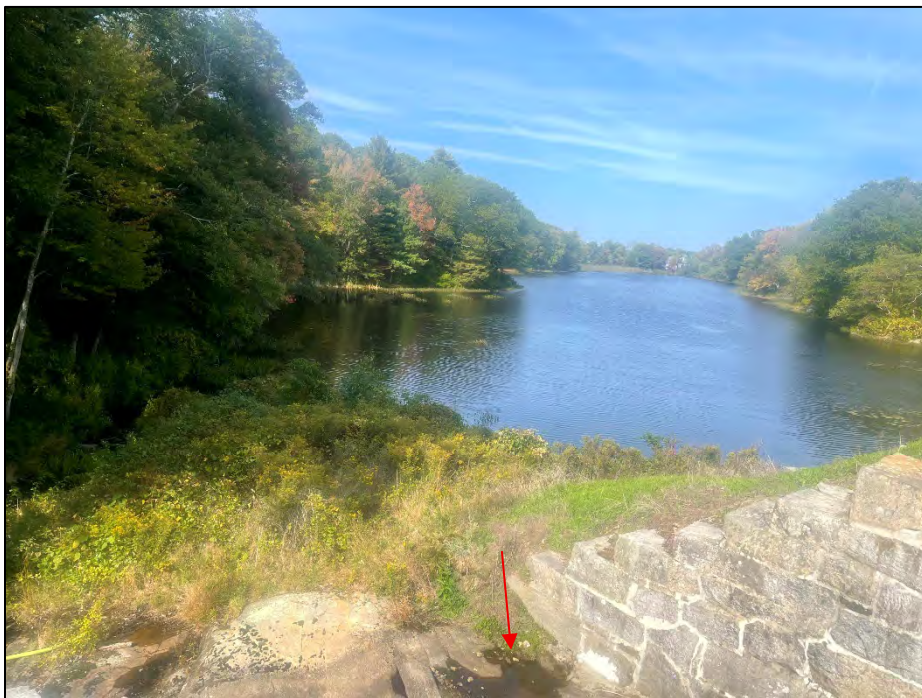
- a. Leakage conditions appear typical with either flow through open joints of masonry and/or stone masonry founded on bedrock as opposed to flow through embankment soils. Continued monitoring is still recommended; however, a concrete approach slab tied into bedrock or other means of leakage deterrent may be needed to address the ongoing leakage.

Photo No. 24.: Tailwater pond (Pascoag Reservoir Lower) as viewed from left of the primary spillway. Note clear leakage out of bedrock joint (arrow).

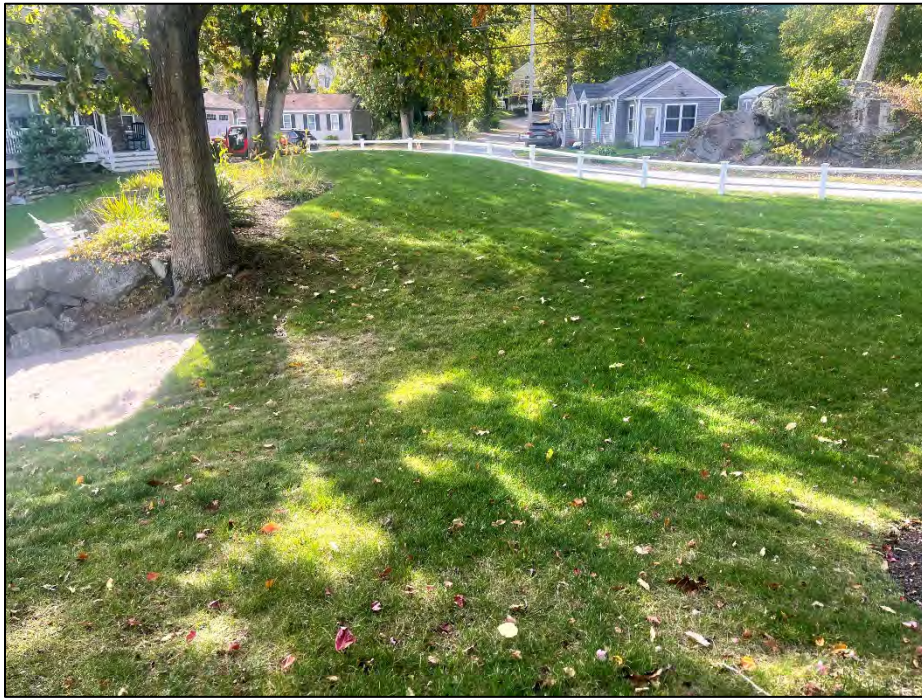
Photo No. 31.: West Dike - Crest as viewed from near STA D0+00 looking left. Note the area of the intentional breach at the left abutment

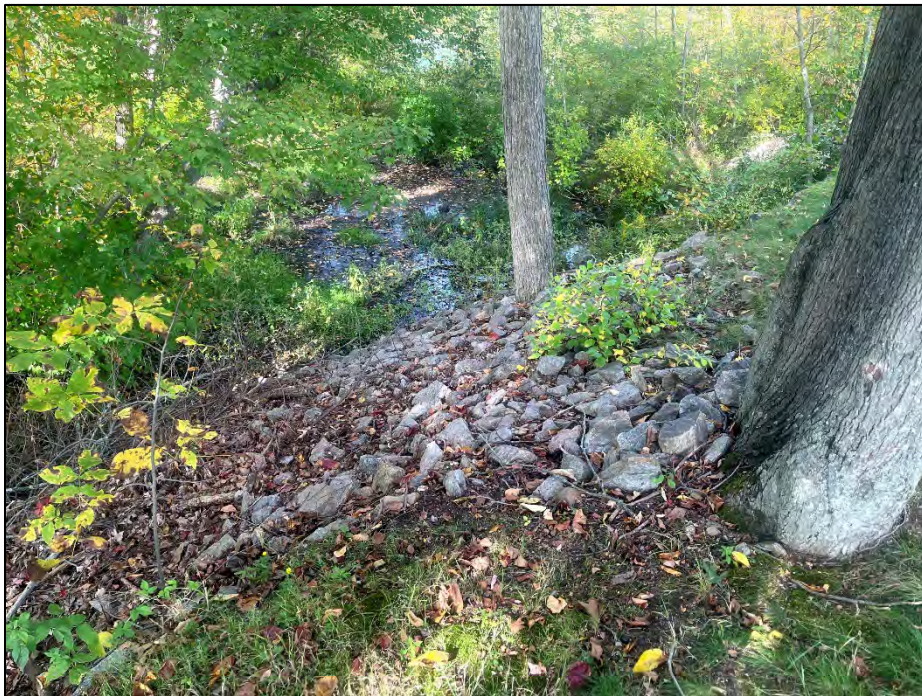
Photo No. 36.: West Dike - Downstream side as viewed from near STA D0+90 looking right.  
Note the trap rock buttress.

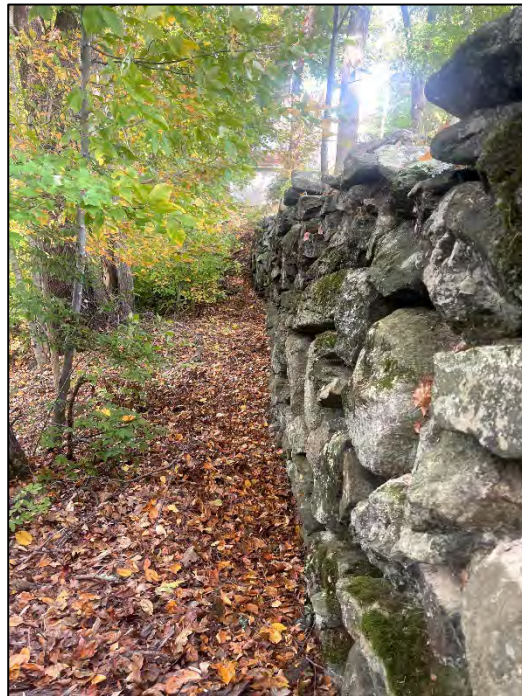
- The downstream dry-laid stone wall is in condition similar to the upstream wall, displaying irregular vertical alignment, bulged wall faces, areas of sand discharge within joints, missing and displaced stones, and isolated areas of collapse.
- Two trap rock buttresses are present along the steepest sections of the wall at the locations of the two failures identified in the 2017 inspection.
- Yard waste continues to accumulate near the wall face close to the right abutment, obstructing visibility of the masonry.
- A downstream wetland complex is present beyond the intact portion of the downstream wall.
- The dike functions as a water-retaining structure during flood conditions. At the time of inspection, water levels upstream and downstream were similar, and the dike did not appear to be impounding water. This condition prevented an assessment for seepage.

Photo No. 38.: West Dike - Downstream side as viewed from near STA D1+50 looking right. Note bulged stone wall.

4. Based on the results of the stability analyses, repair both the upstream and downstream walls. Reset the displaced stones as necessary to form vertically and horizontally regular walls. This may include providing additional chinking stones, repointing, or installing a stone buttress in front of the walls for added stability.

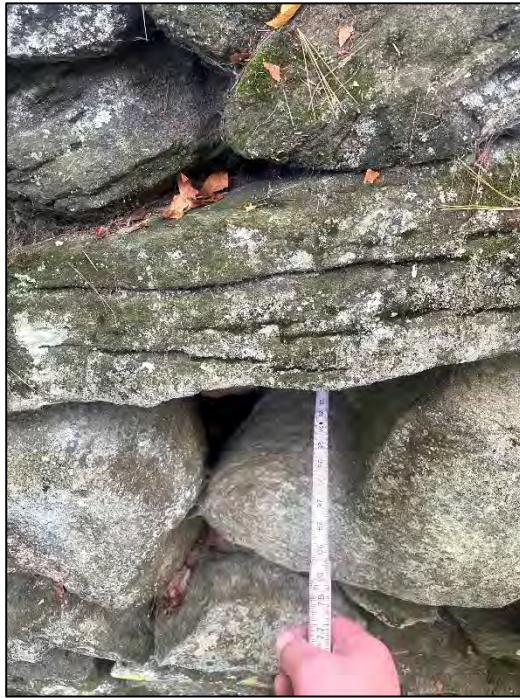
Photo No. 39.: West Dike - Typical gaps measured within the downstream stone wall. Photo of a 24 inch deep gap measured near STA 1+50.

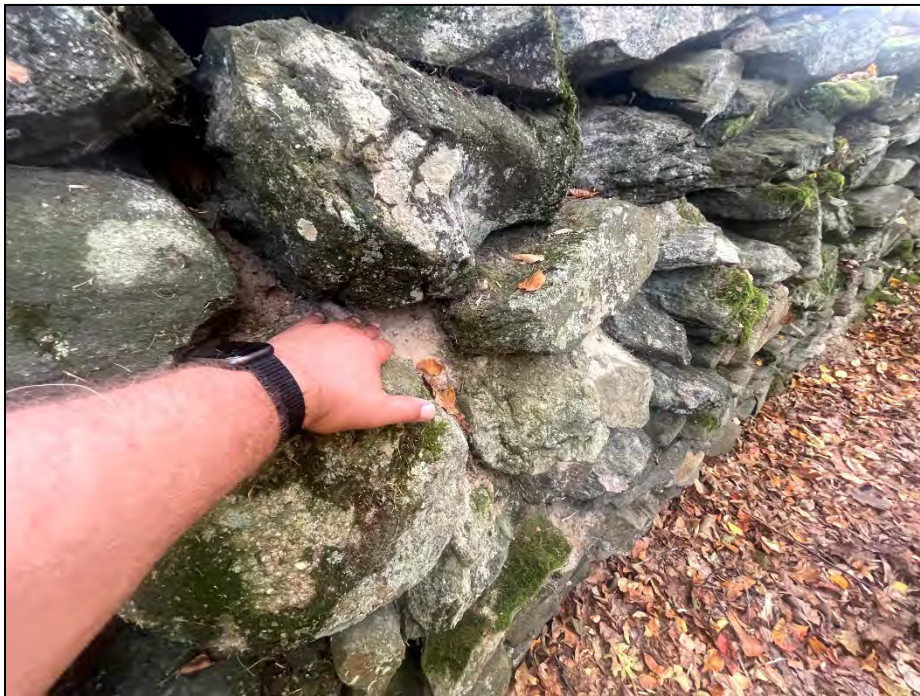
Photo No. 40.: West Dike - Sand discharge within gaps of downstream wall as viewed from near STA 2+00 looking right.
